Project Summary
2009 Maintenance Sinkhole Filling Project
Contract AM-584-09

**North Dakota Public Service Commission
2009 Maintenance (Sinkhole Filling) AML Project Summary**

Project Type:	Surface backfilling of dangerous sinkholes
Primary Locations:	Thirteen properties near the cities of Wilton, Dickinson, Noonan, Beulah, and Garrison, North Dakota
Project Dates:	October 28 to November 30, 2009
Contractor:	Basaraba Excavating & Dirt Works, L.L.C. of Wilton, ND
Project Cost (To Date):	\$102,132.50

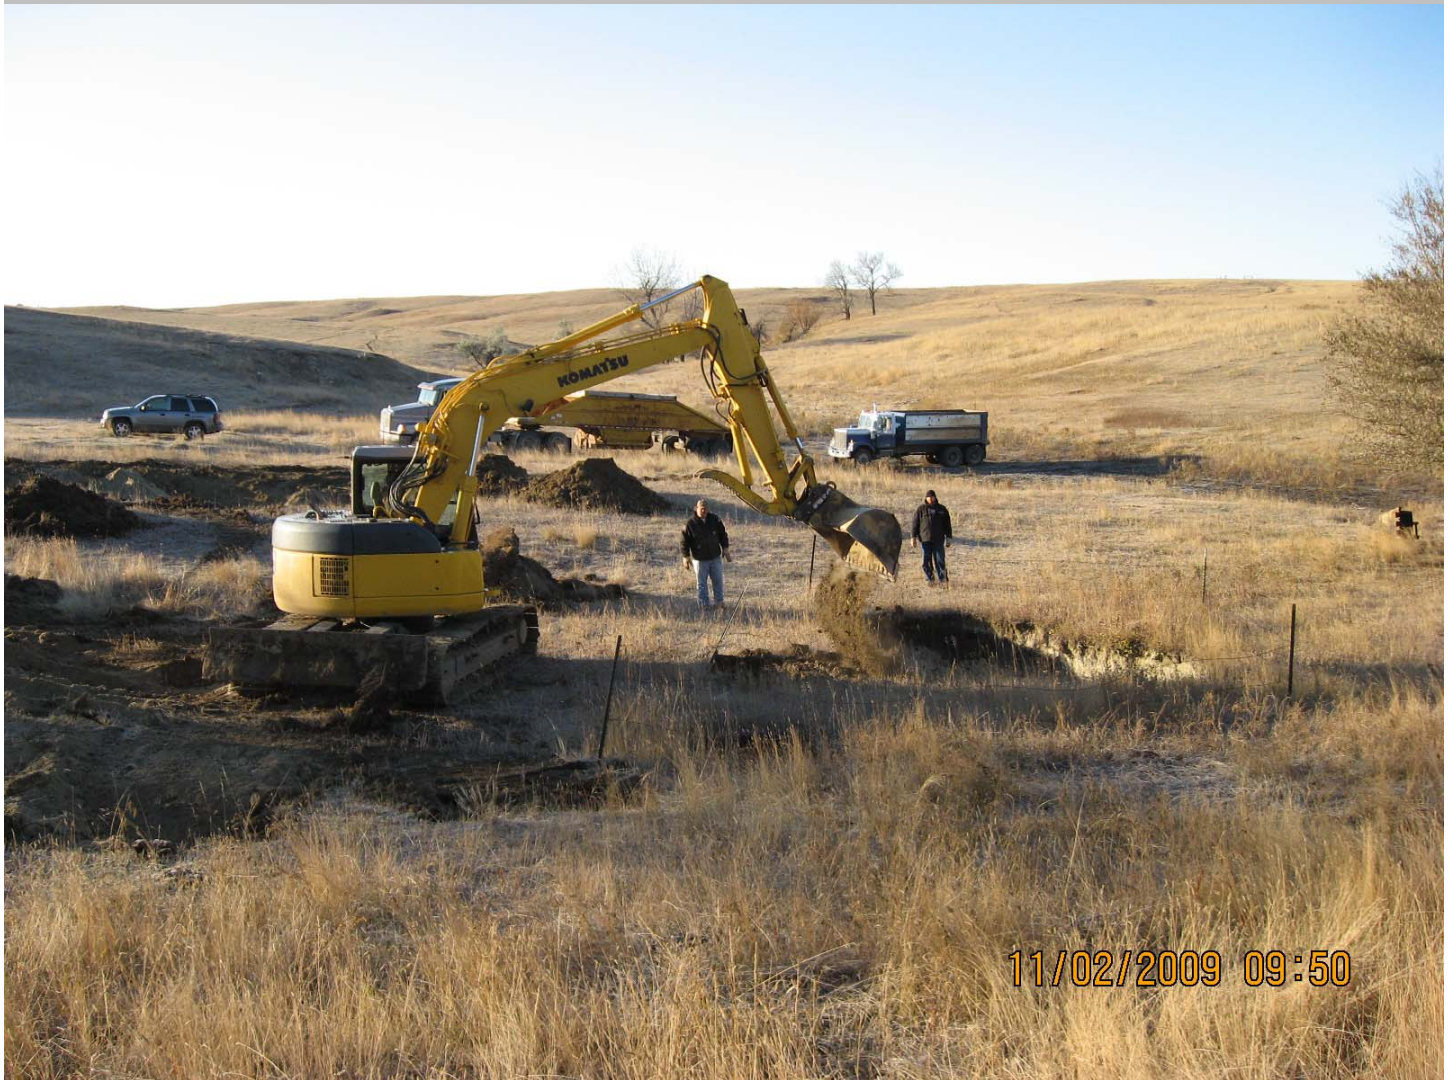
Cover Photo: The cover photo shows sinkhole filling operations on Mike Wolf's property about 3 miles east of Dickinson, ND. Ten large sinkholes were filled at this location from November 2-3, 2009. The Lehigh Briquetting Company operated an underground coal mine in this area from 1921 until 1949, producing more than 1.3 million tons of coal for domestic use, electrical generation and briquetting.

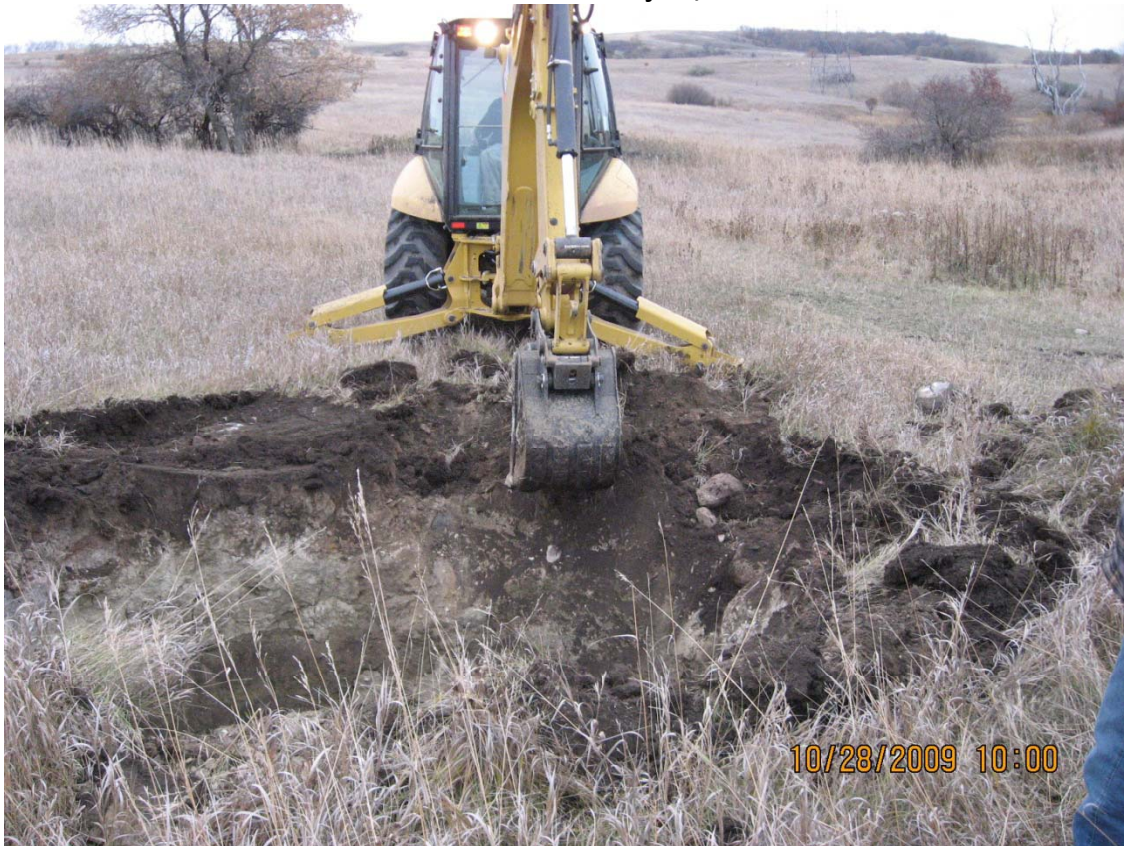
The 2009 Sinkhole Maintenance Project began October 28 on property owned by Stan Murrey about 4 miles southwest of Wilton. The historic Little Casino Coal Mine may have operated at this location circa 1883. Four sinkholes were filled on this property including this one which was approximately 13 feet deep.

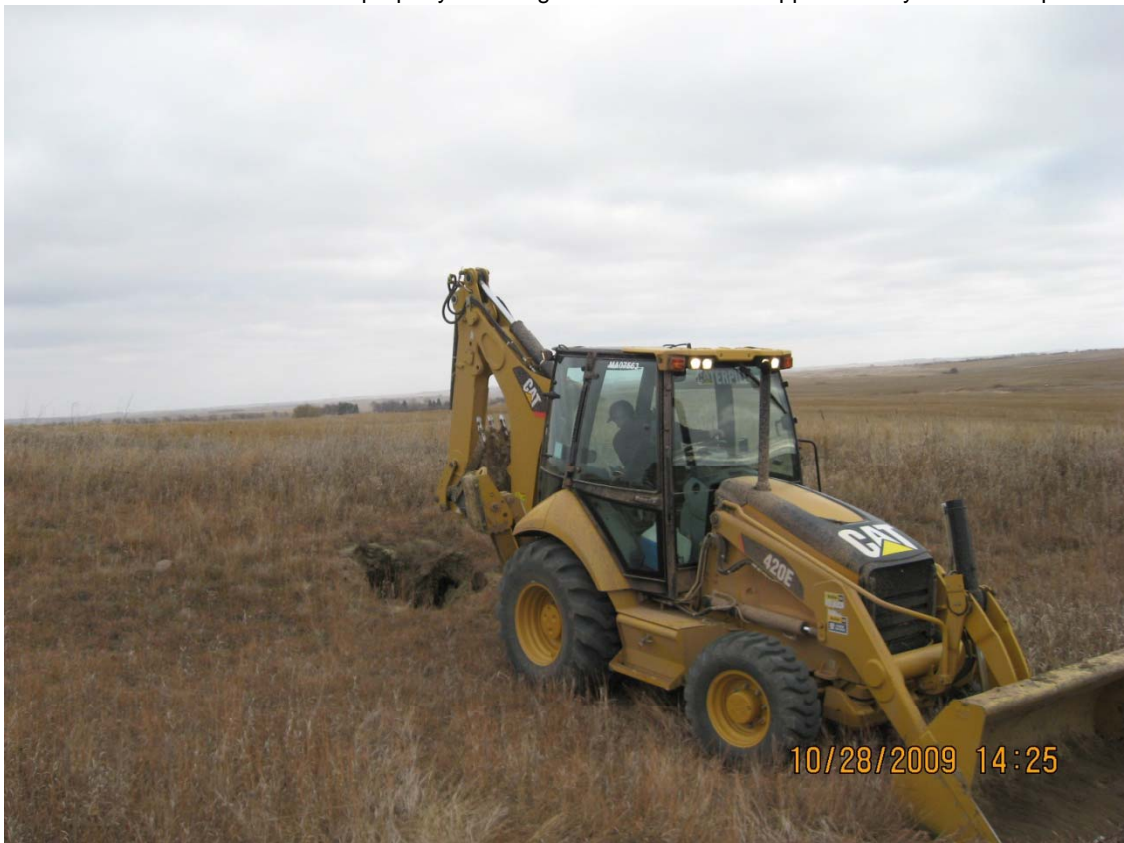
This sinkhole was located in the east ditch of 80th Street Northeast, about 4 miles northeast of Baldwin or six miles southeast of Wilton. It was reported by the Burleigh County Highway Department on September 15, 2009 and was about six feet wide and 20 feet deep.

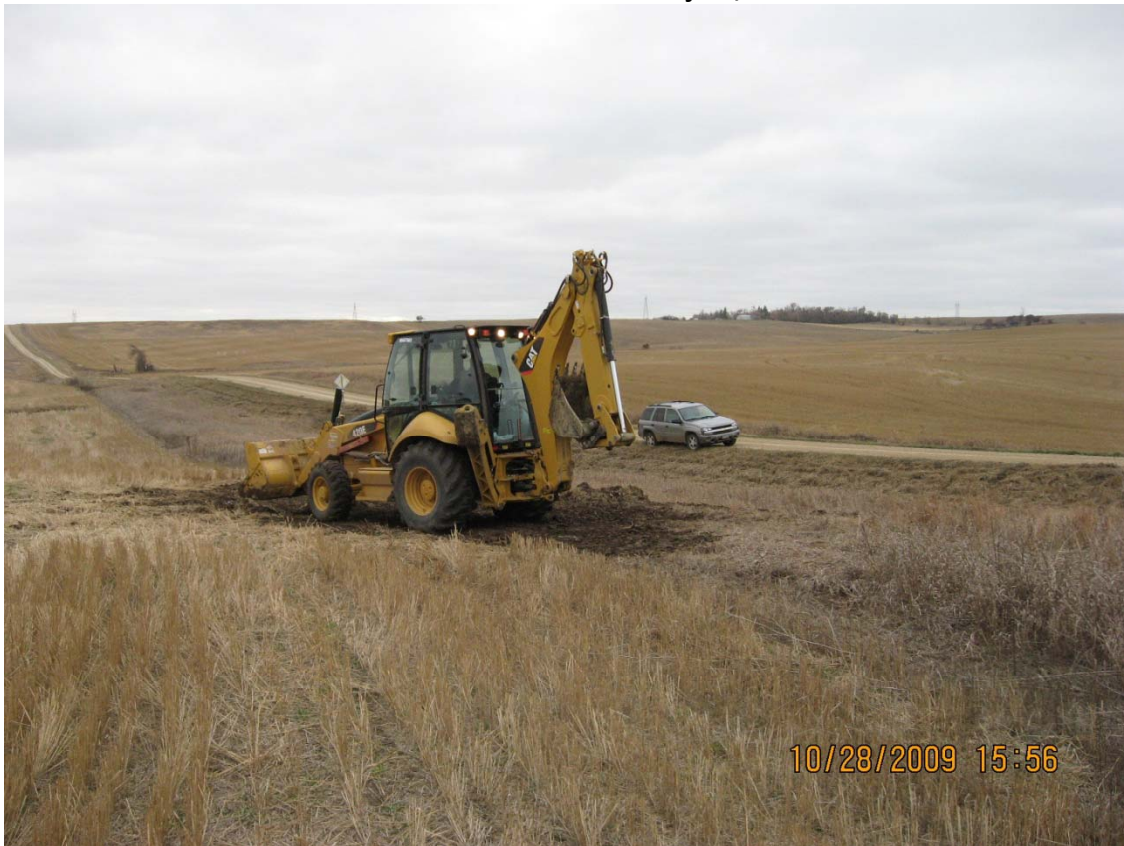
This is another photo of the sinkholes along 80th Street after they were filled. Most of the fill came from a nearby rock pile. No mine maps or other documentation are available for the abandoned mines at this location.

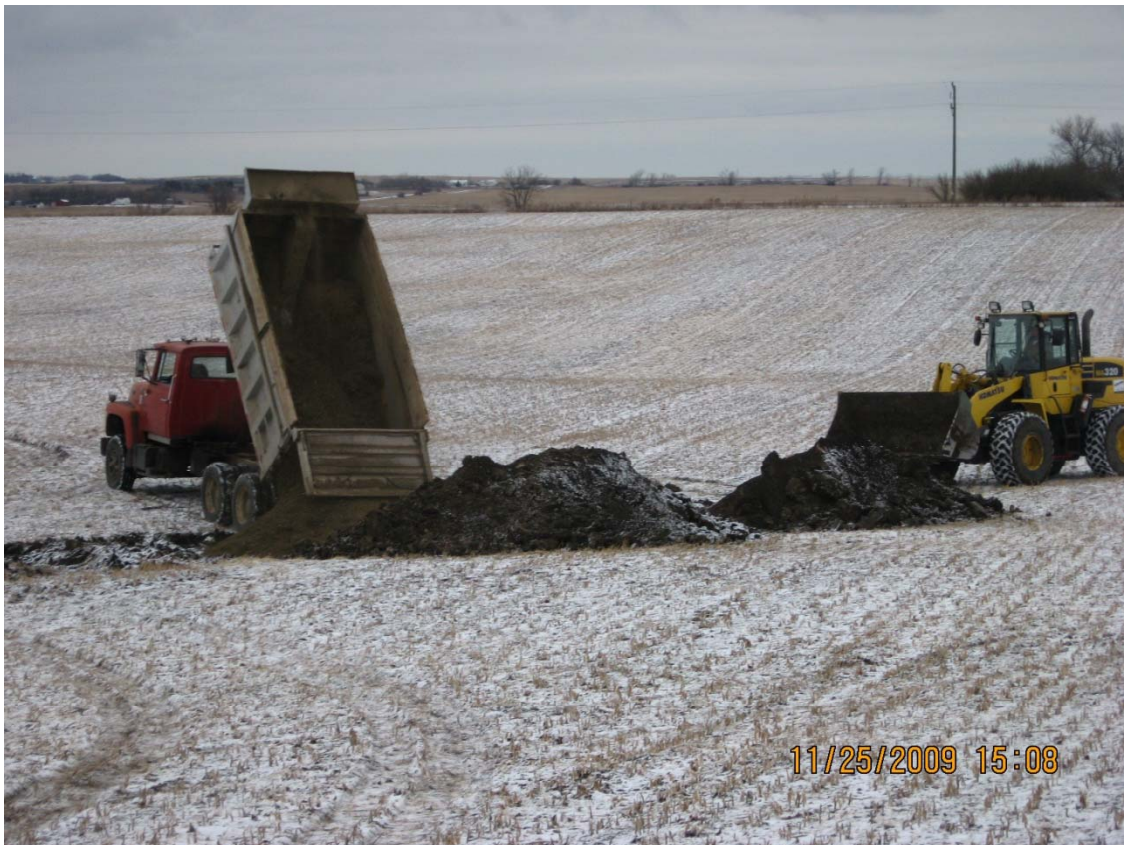
Eight dangerous sinkholes were filled on property owned by Jim Krzmarzick approximately 2 miles east of Wilton. The sinkhole in this photo was in a harvested flax field. It was about 12 feet wide and 15 feet deep.

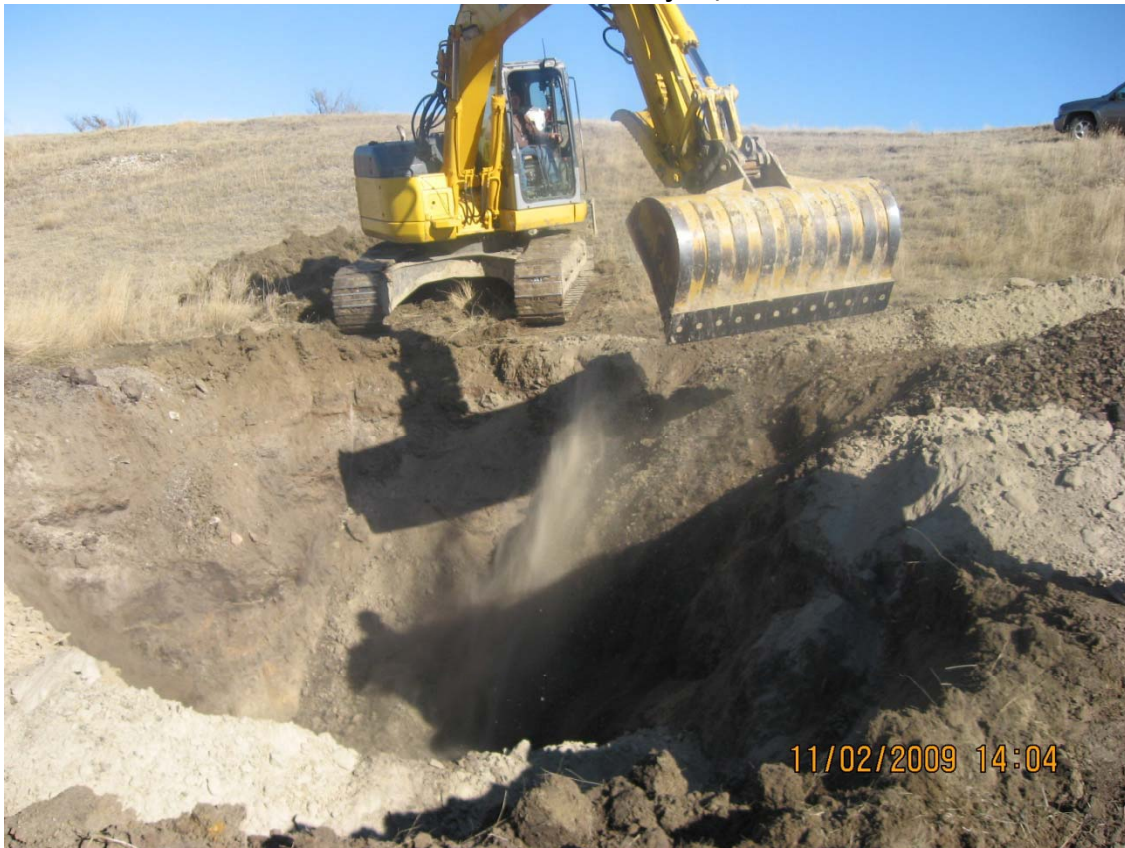
Ten large sinkholes were filled November 2-3 on property owned by Mike Wolf about 3 miles east of Dickinson. More than 1,600 cubic yards of dirt was needed to fill these holes at a cost of \$5,805.

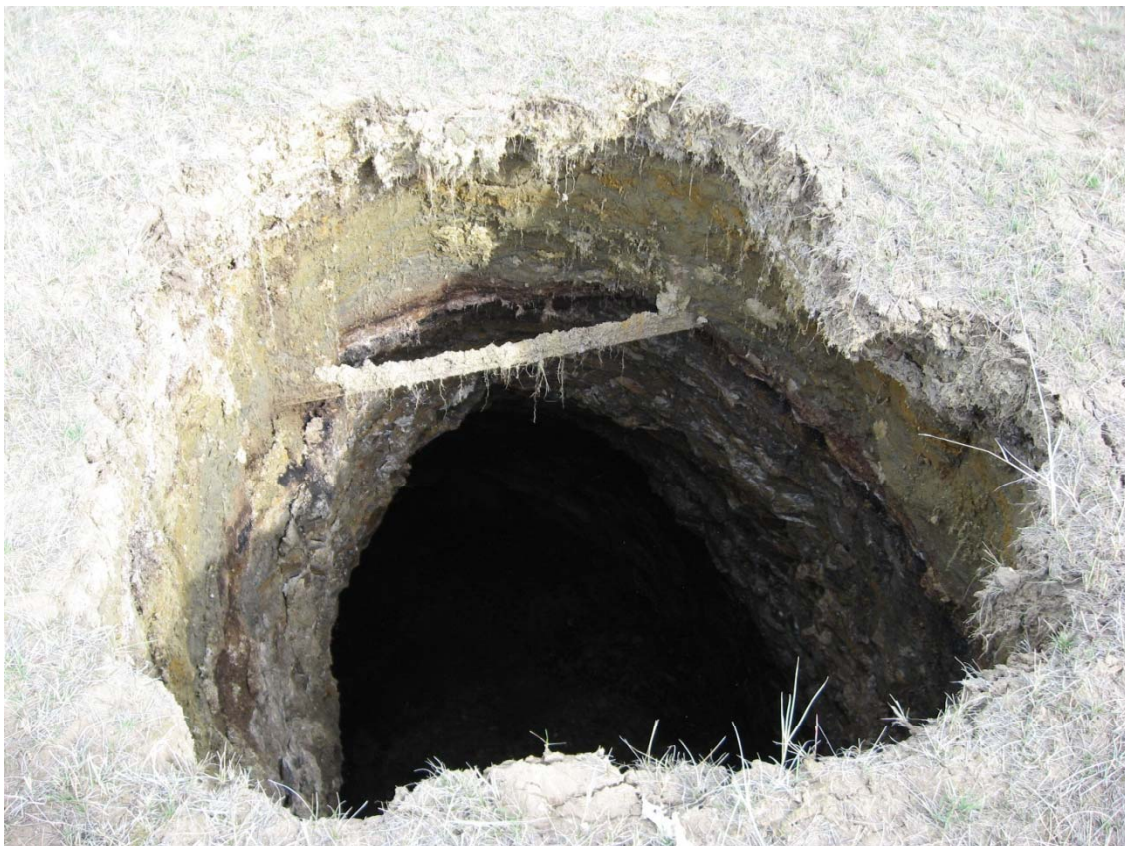
One of the sinkholes on Wolf's property had a power line running across it. Representatives of Roughrider Electric Cooperative were onsite to monitor the filling of this sinkhole on November 2. It was about 25 feet deep.

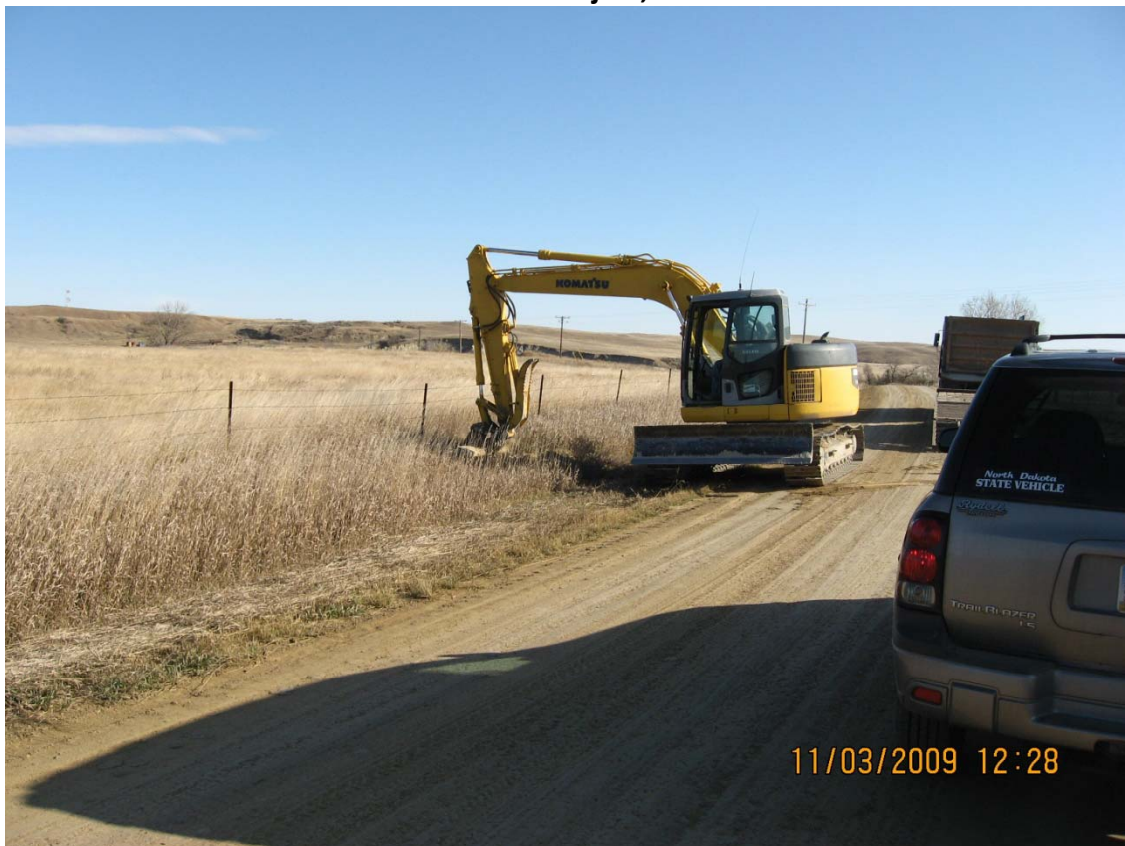
A dangerous sinkhole was also filled on the north shoulder and ditch of Lehigh Drive approximately 3 miles east of Dickinson.

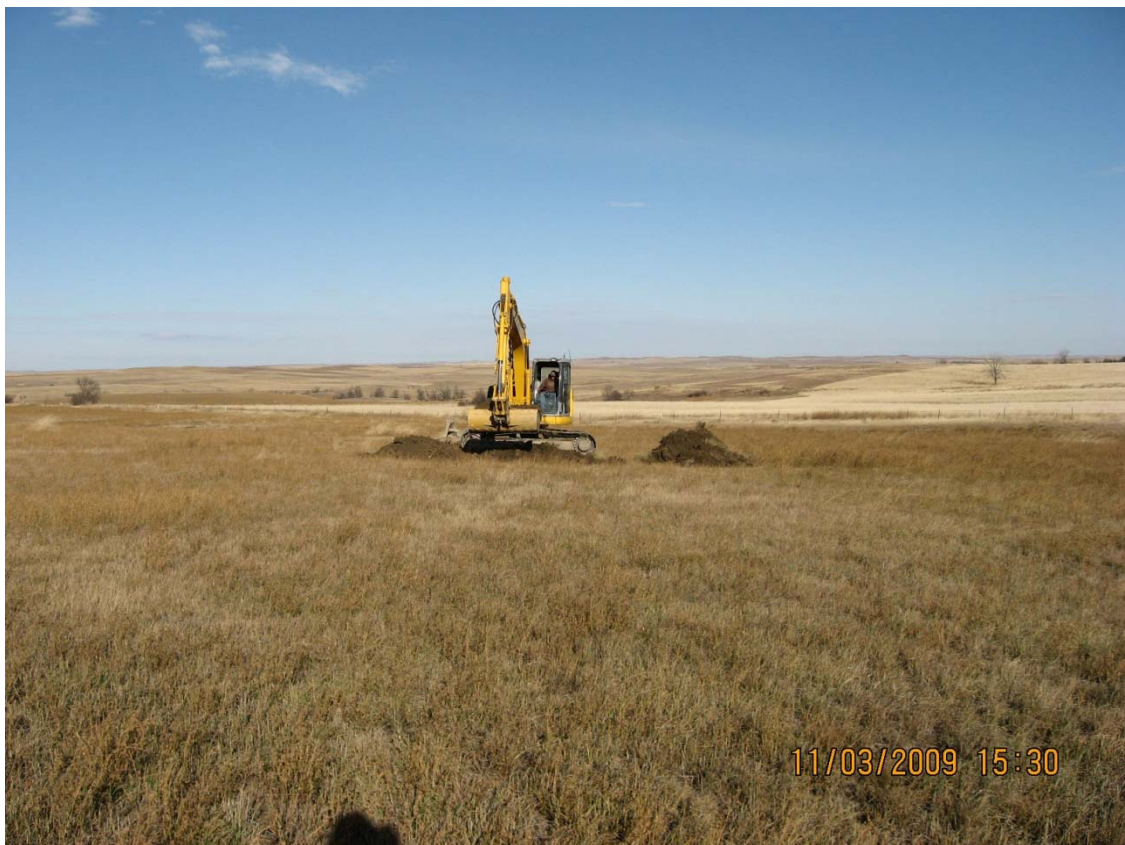
Six sinkholes were filled on property owned by Bill Jablonsky about 12 miles northeast of Dickinson. No mine maps or other documentation are available for the abandoned mine at this location.

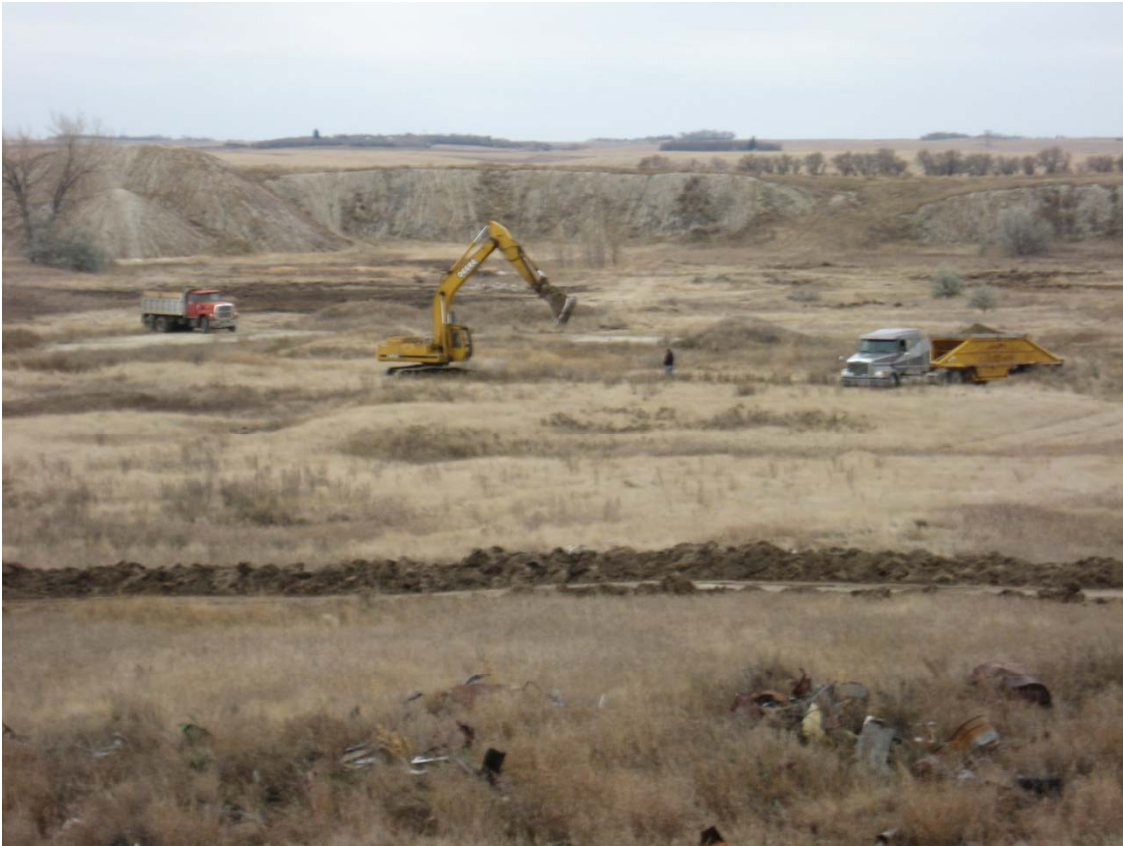
Approximately 181 sinkholes were filled on a tract of about 30 acres owned by the Noonan Landfill a mile southeast of Noonan. Four pieces of heavy equipment and three trucks worked for five days at this site and the cost was \$48,770.

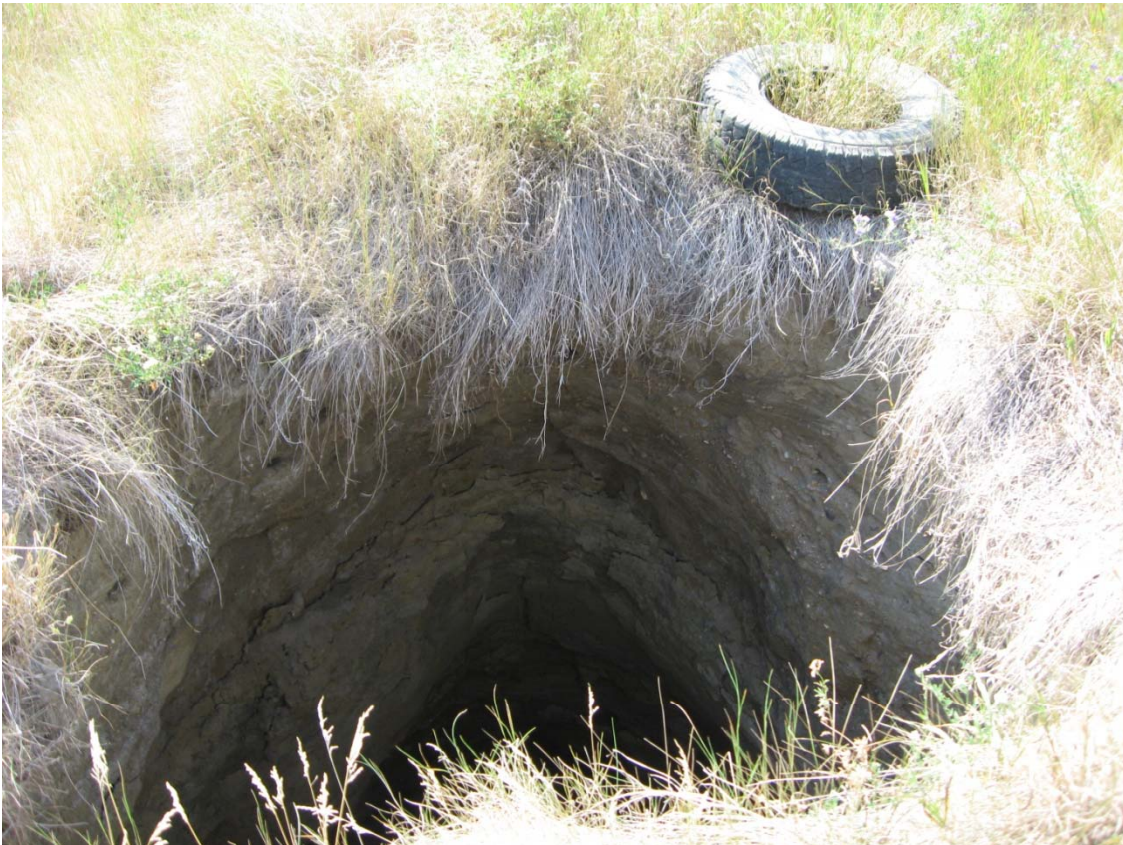
This sinkhole, on property owned by James Kimball about a mile south of Noonan, was difficult to see because of the tall grass, and very dangerous. It was about 12 feet in diameter and 25 feet deep.

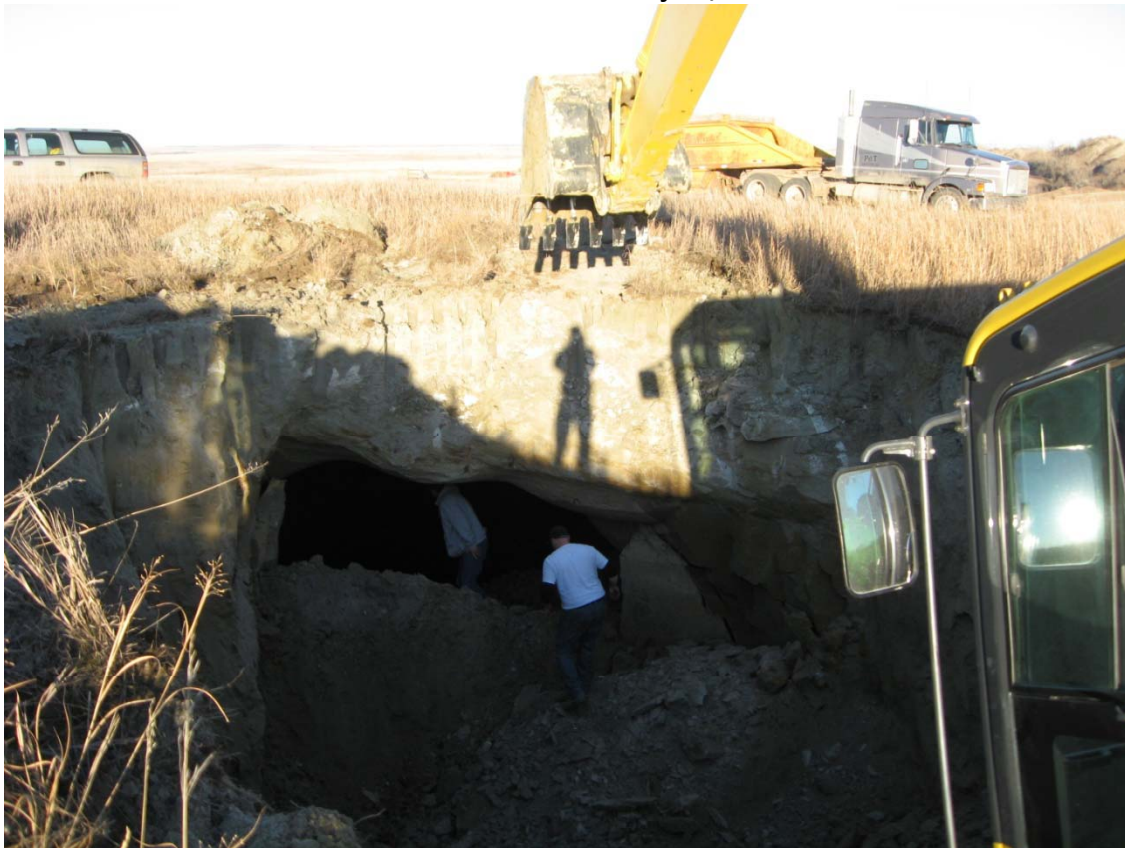
Approximately 80 sinkholes were filled on properties owned by ND Game and Fish Dept., Garner Sailer, Florence Pfliger and Curt Michaelson, near Beulah. Several of the sinkholes were quite large and extended laterally and diagonally.

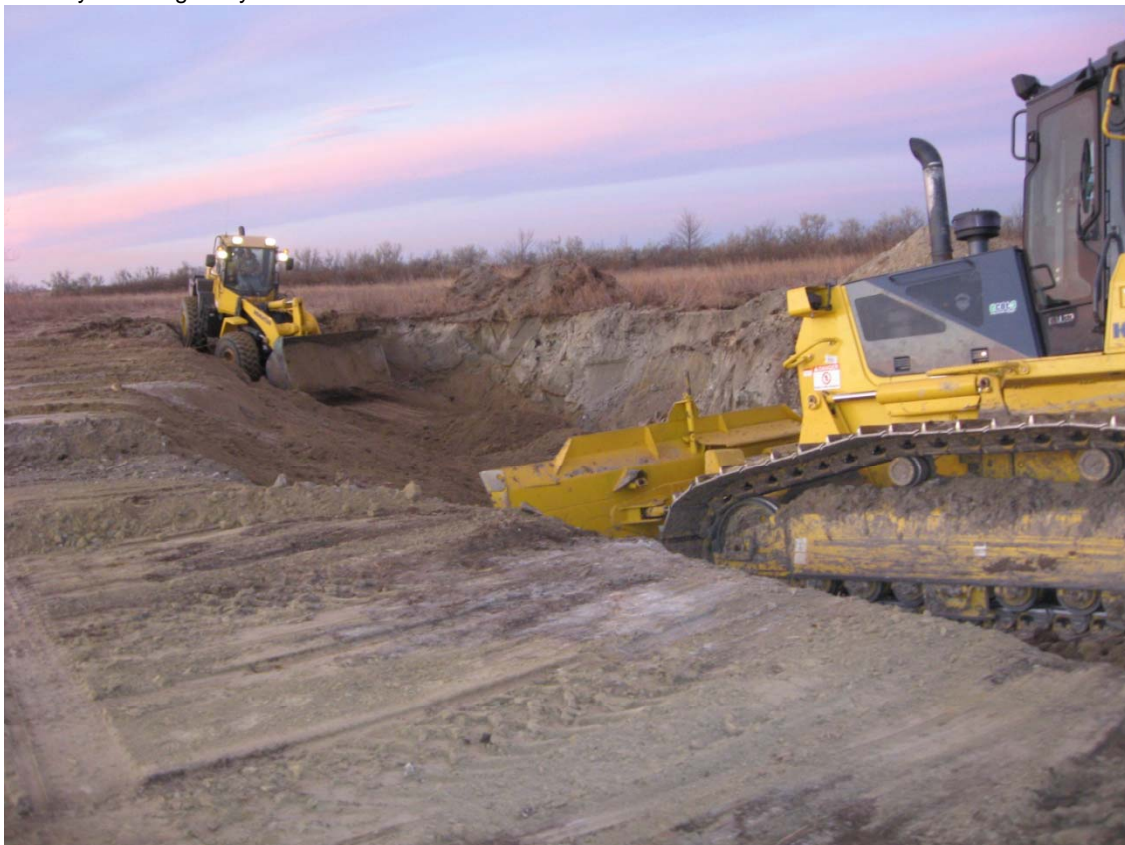
This shows a bulldozer and payloader filling a large sinkhole on ND Game and Fish property about 4 miles northeast of Beulah.

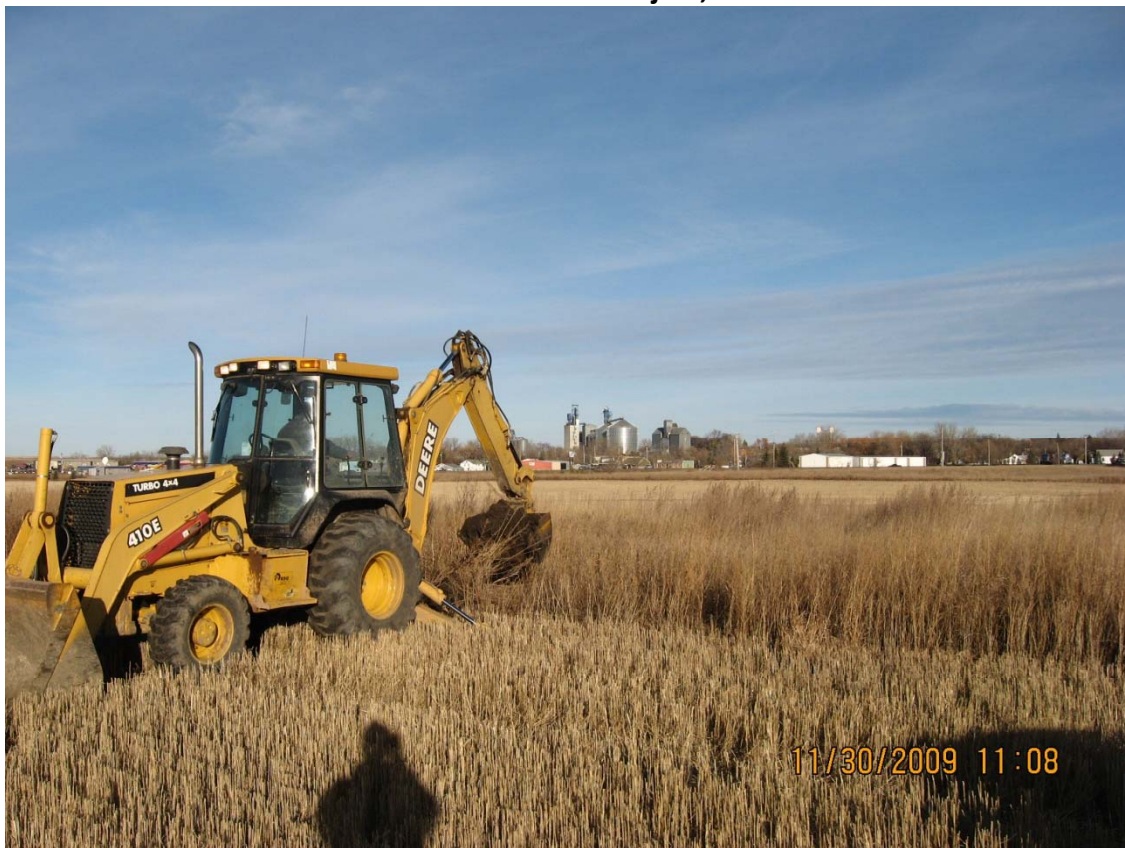
Seventeen sinkholes were filled on Dave Mautz' property located directly south of Garrison. The sinkhole in this photo is difficult to see, as it had been farmed around, but it was about 20 feet deep and 130 cubic yards (or about 8 truckloads) of dirt were needed to fill it..

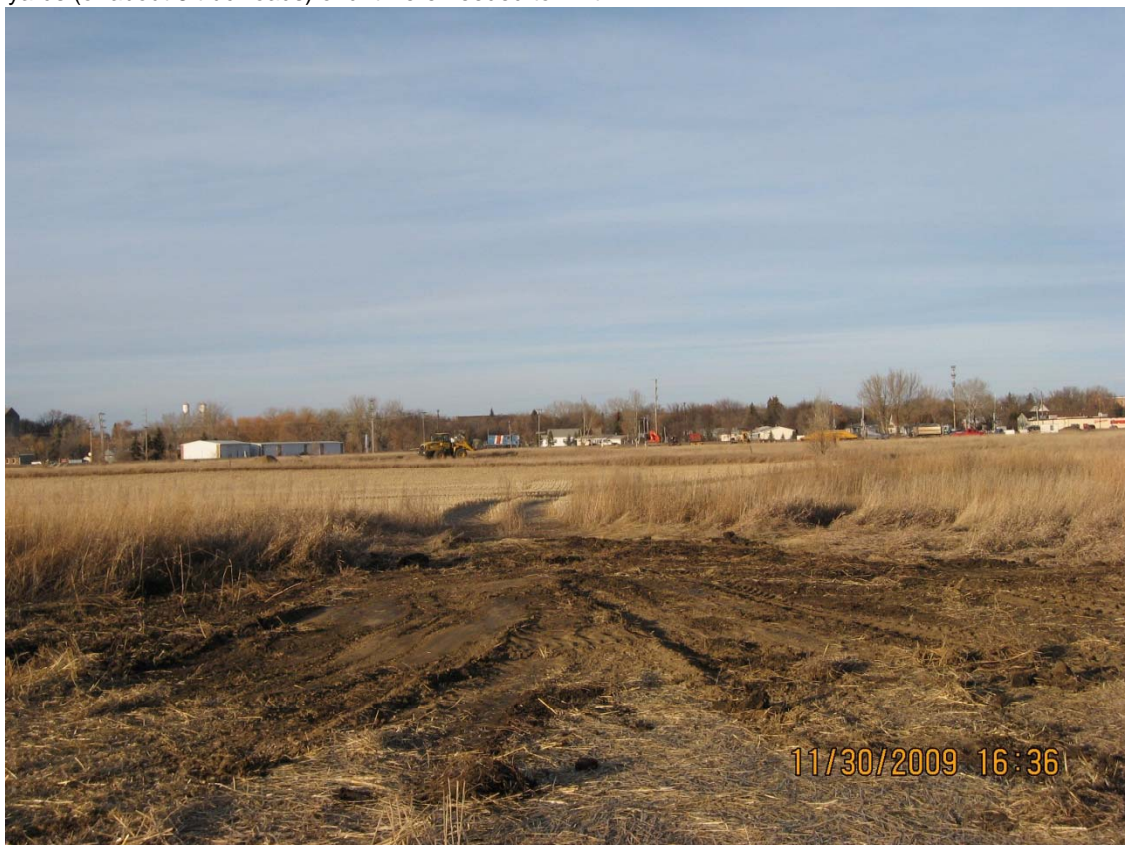
This shows the sinkhole after it was filled and the topsoil had been respread.
